Pre-Purchase Inspection Findings

Executive summary

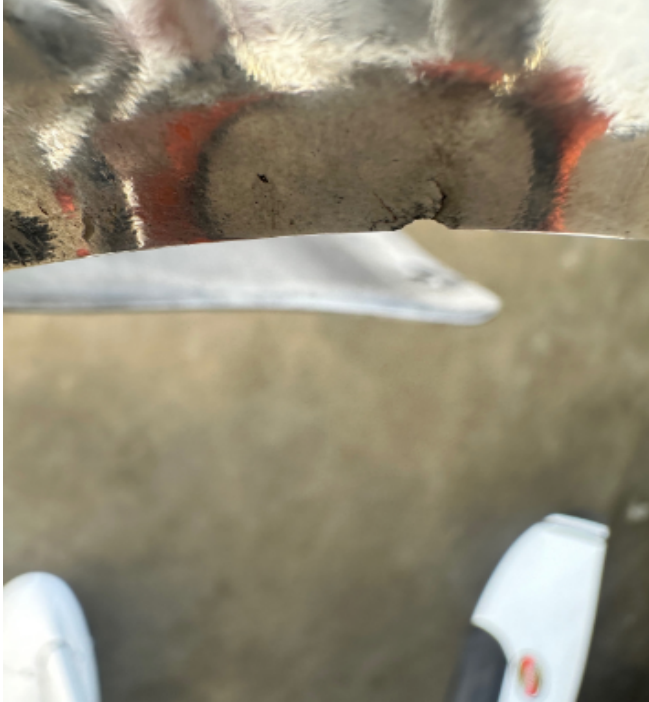
Item 7

6	Popped rivet in center rubber baffling around magnetos	SR22MM	Replace rivet	\$0-\$100
7	Spinner cracked at TKS drop nozzle. Nozzles are chafing the spinner (AIRWORTHINESS ITEM)	Hartzelle CS Prop MM	Dress spinner to remove cracks. Adjust TKS nozzle to prevent chafing	\$250
8	Propeller TKS boots cracking and dry-rotted	Hartzelle CS Prop MM	Apply PBS boot sealant to preserve boots temporarily. Replace in the future	\$350
9	Battery #2 is past 2 year replacement recommendation	SR22MM	Replace #2 battery. PN: 50979-001	\$400
10	LH/RH wing fuel vent panels cracked near fuel vent inlet. Tygon tubing is stiff and clamps rusted. (AIRWORTHINESS ITEM)	SR22MM	Repair/replace fuel tank vent inlets. Replace tygon vent tubing & clamps	\$450
11	LH wing, inboard fuel sending unit leaking at base gasket (AIRWORTHINESS ITEM)	SR22MM	De-fuel tank. Replace gasket & leak check	\$350
12	Popped rivet noted in RH wing, inboard TKS panel (AIRWORTHINESS ITEM)	SR22MM	Install new rivet	\$100

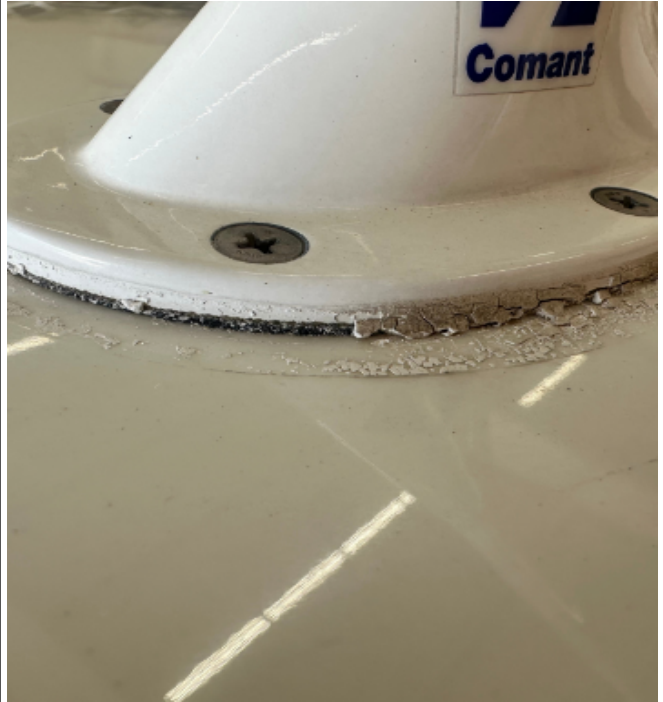
Item 13

13	Upper fuselage antenna seals dry-rotted	SR22MM	Replace seals	\$350
14	Main cabin door foam seals dry-rotted	SR22MM	Replace seals	\$350
15	Ignition switch loose in panel (AIRWORTHINESS ITEM)	SB2X-74-02	Comply with SB2X-74-02	\$150
16	Avionics had numerous faults during run-up (AIRWORTHINESS ITEM)	SR22MM	Owner swapped #2 430 with similar unit for repair. Configuration errors found.	UNK
17	Aft RH overhead light missing switch cover	SR22MM	Install switch cover	UNK
18	Rocket ignitor replacement over due (AIRWORTHINESS ITEM)	SB2X-95-27R1	Comply with SB2X-95-27R1	UNK
19	Crew seat break-over is due	SB2X-25-30R1	Comply with SB2X-25-30R1	\$250
